Manhole Inspection Summary

Manhole # S49A__044MH

Insp Date: **5/6/08 2:08 PM**

Location Address: **rear 437 n lakewood ave**

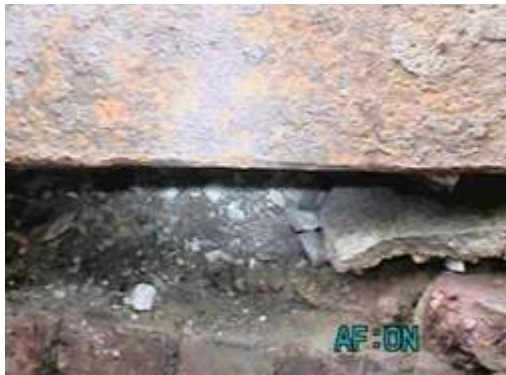
Defect 2

Condition: ☐ Sound ☐ Cracked ☐ Root Intrusion ☐ Loose Brick ☒ **Deteriorated**

missing brick corbel

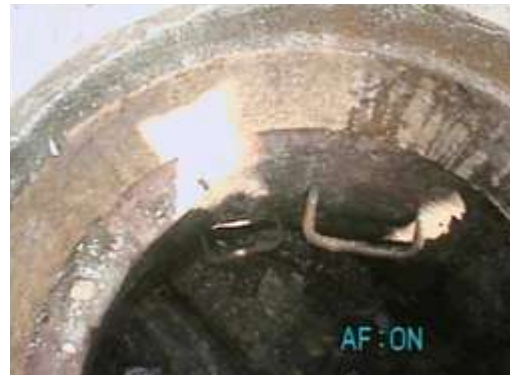
Defect 1

Steps Count: **2** Missing: **0** ☒ **Corroded**

steps

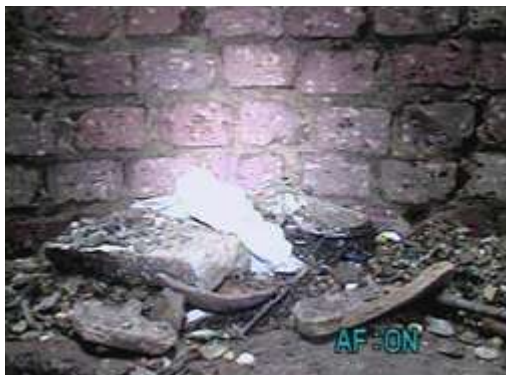
Defect 4

Condition: ☐ Sound ☐ Cracked ☐ Root Intrusion ☐ Deteriorated ☐ Leaks ☒ **Debris**

bench debris

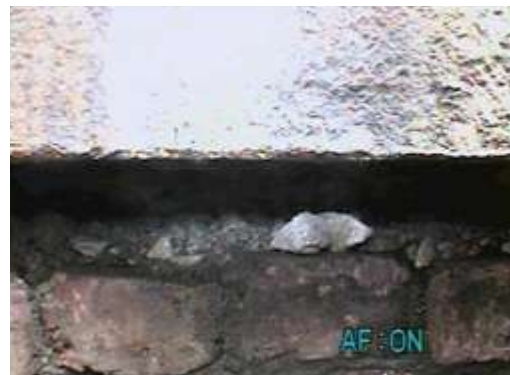
Defect 3

Condition: ☐ Sound ☐ Cracked ☐ Root Intrusion ☐ Loose Brick ☒ **Deteriorated**

deteriorated, frame adjustment

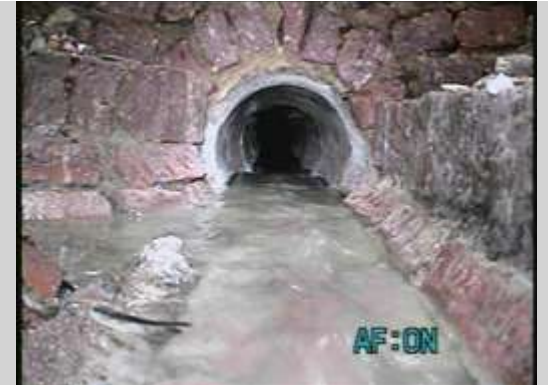
12 O'Clock Outflow

8 in. Circular Gravity Sewer
Pipe Out @ 12 O'Clock

Pipe Material: **Clay** ☐ Pipe Lined

Invert Depth: 7.18 (ft.) Flow Characteristics: **Fast**

Infiltration: **None** Pipe Seal Cond: **Unknown**

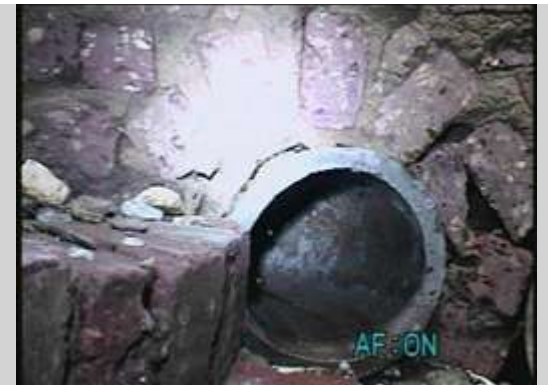
5 O'Clock Inflow

8 in. Circular Gravity Sewer
Pipe In @ 5 O'Clock

Pipe Material: **Clay** ☐ Pipe Lined

Invert Depth: 7.15 (ft.) Flow Characteristics: **None**

Infiltration: **None** Pipe Seal Cond: **Unknown**

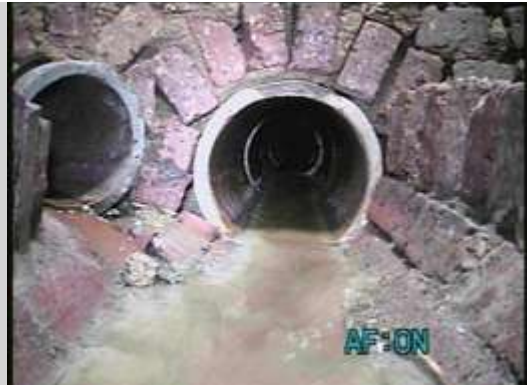
6 O'Clock Inflow

8 in. Circular Gravity Sewer

Pipe In @ 6 O'Clock

Pipe Material: **Clay** ☐ Pipe Lined

Invert Depth: 7.12 (ft.) Flow Characteristics: **Fast**

Infiltration: **None** Pipe Seal Cond: **Unknown**

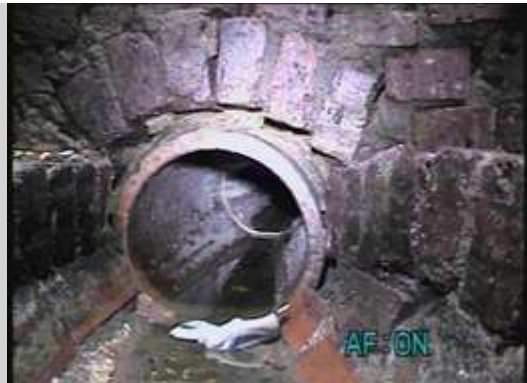
9 O'Clock Inflow

8 in. Circular Gravity Sewer

Pipe In @ 9 O'Clock

Pipe Material: **Clay** ☐ Pipe Lined

Invert Depth: 7.03 (ft.) Flow Characteristics: **None**

Connects To: **Dead End**
